Inspection Report for LAUDERDALE LAKES DAM

DNR Field File No. 64.15
Walworth County, Wisconsin

July 12, 2022

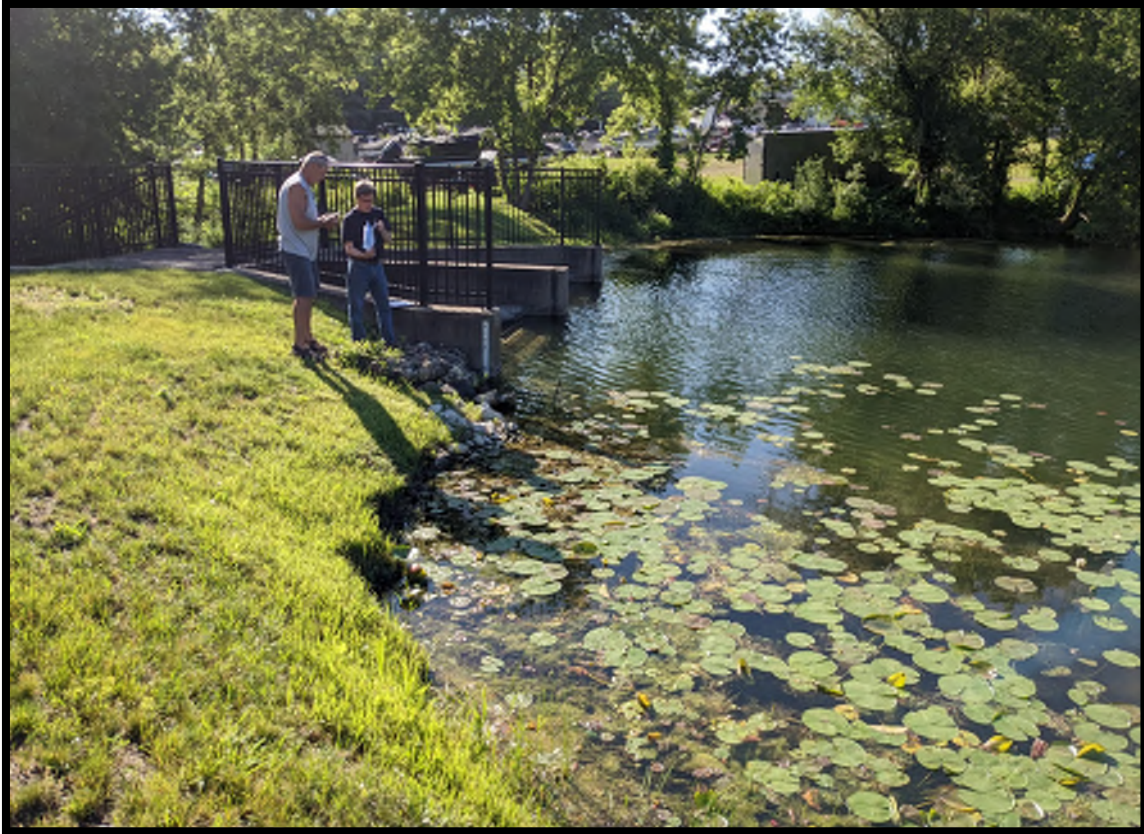
**Upstream view of primary spillway from north bank
0021006162201.jpg**

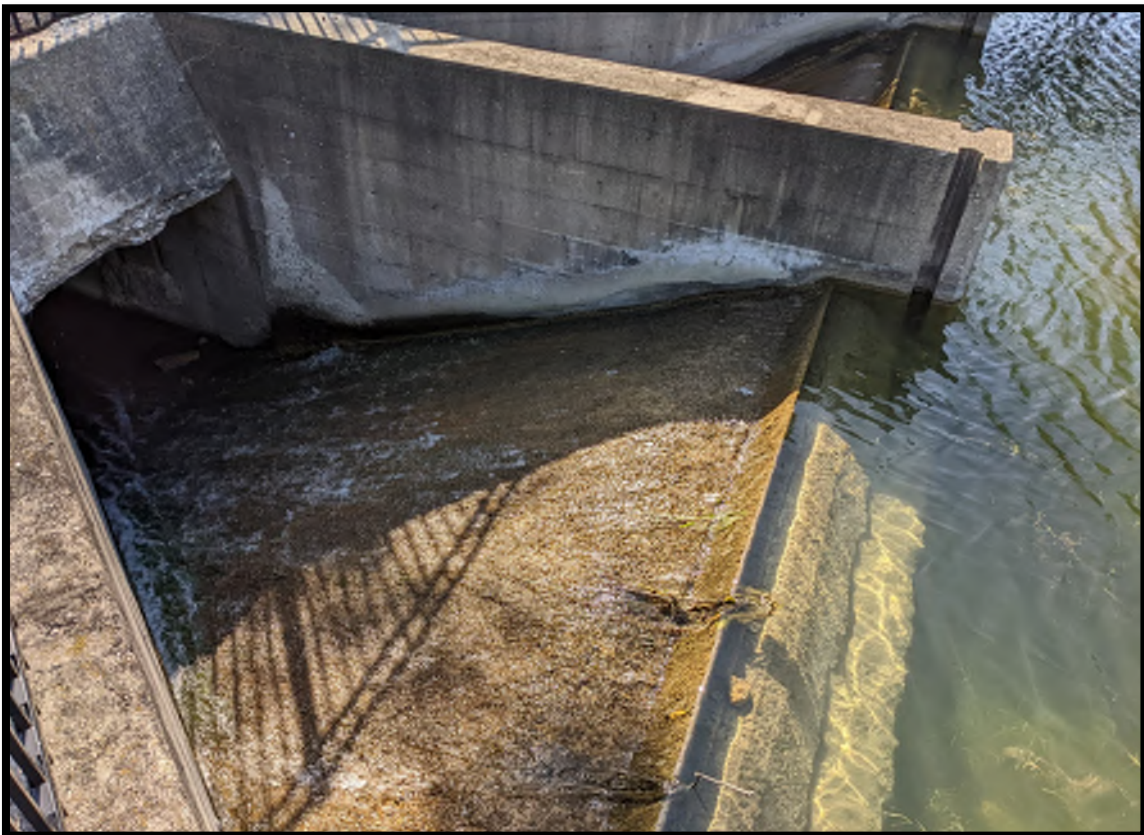
**View of north chute with overflow into Honey Creek
0021006162202.jpg**

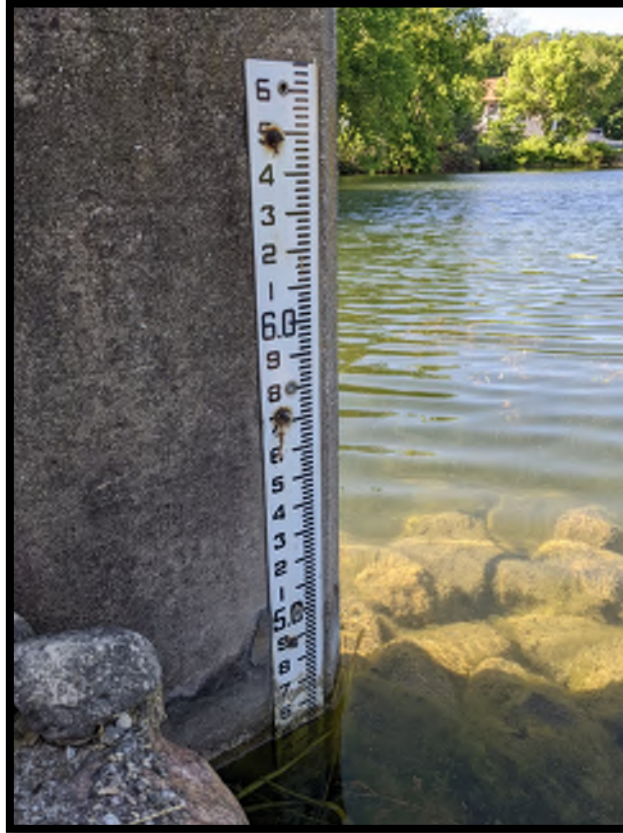
Gauge and water level on primary spillway
0021006162203.jpg

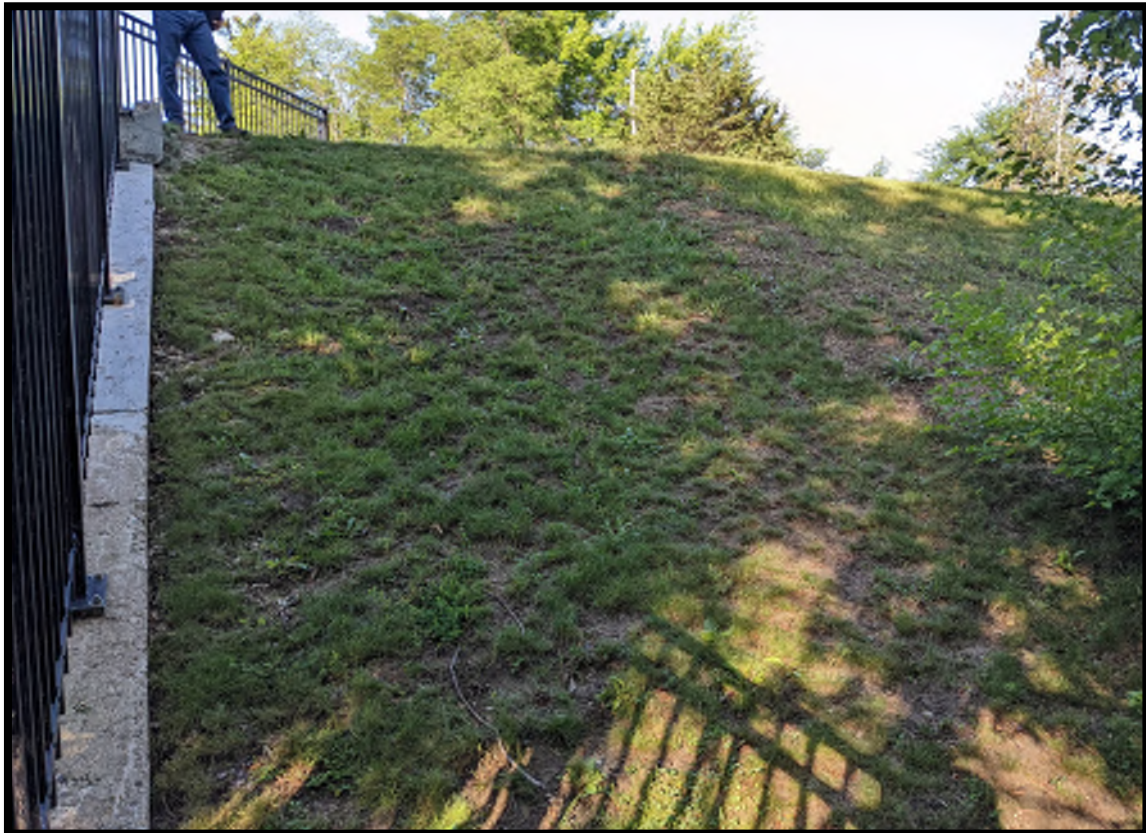
C. Ground cover	<input checked="" type="checkbox"/>	<input checked="" type="checkbox"/>					2
Type (grass, crown vetch, other):							
Quantity (bare, sparse, adequate, dense):							
Appearance (too tall, too short, good):			Sparse grass cover along west embankment. Recommend seed and fertilizer to establish denser vegetative cover				
2 Erosion							
<input checked="" type="checkbox"/>	No problem	<input type="checkbox"/>	Not applicable	<input type="checkbox"/>	Could not inspect

West (right) embankment looking upstream
0021006162204.jpg

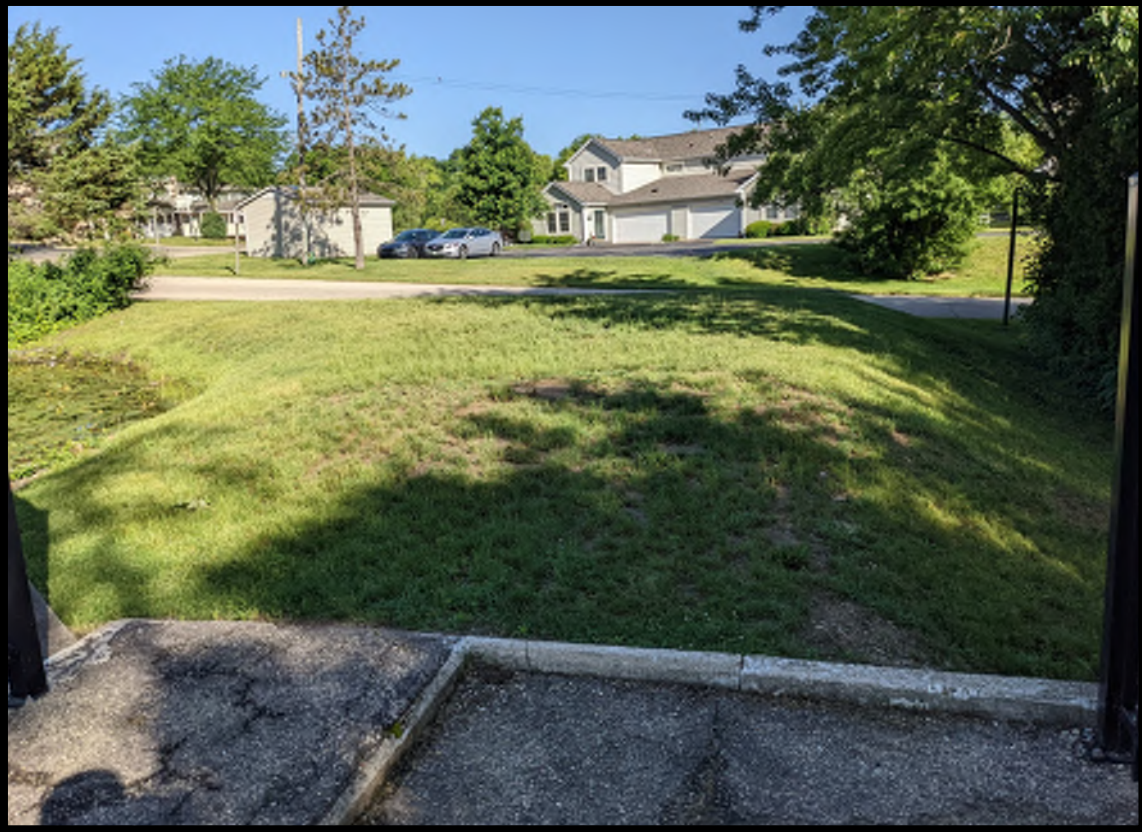
**West embankment looking northwest
0021006162205.jpg**

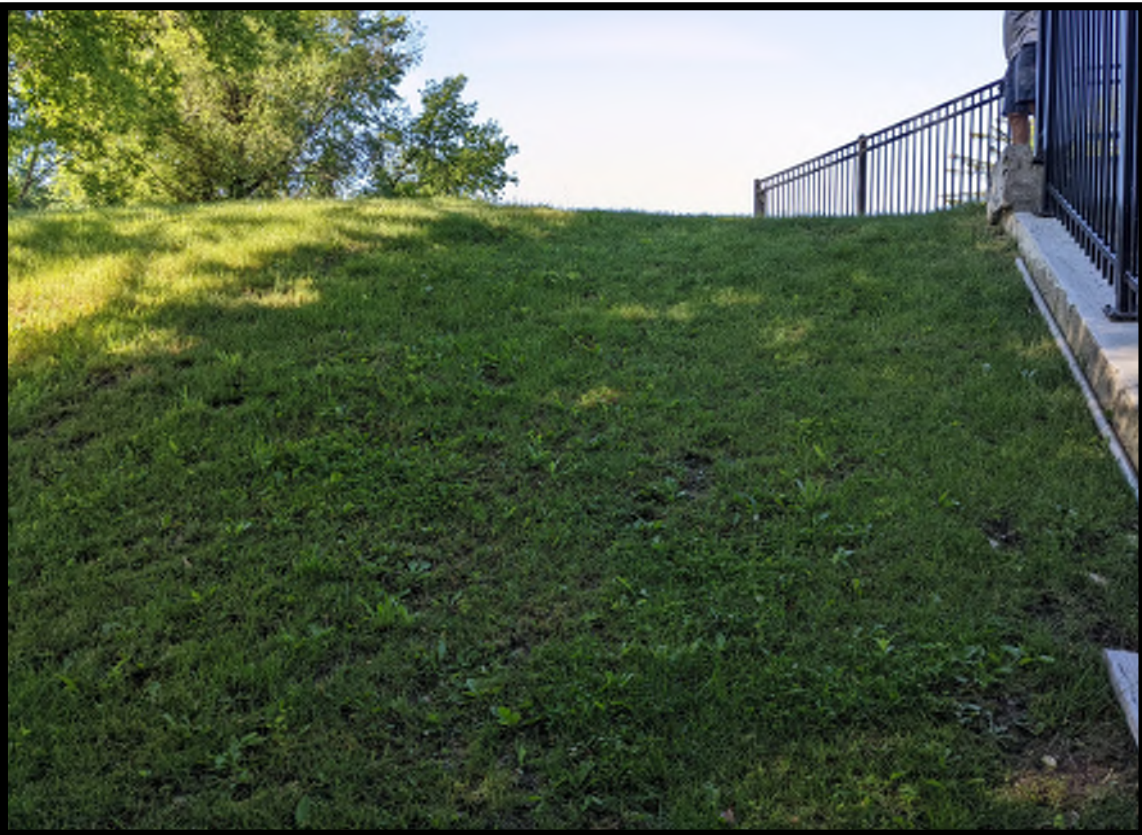
**East (left) embankment looking upstream
0021006162206.jpg**

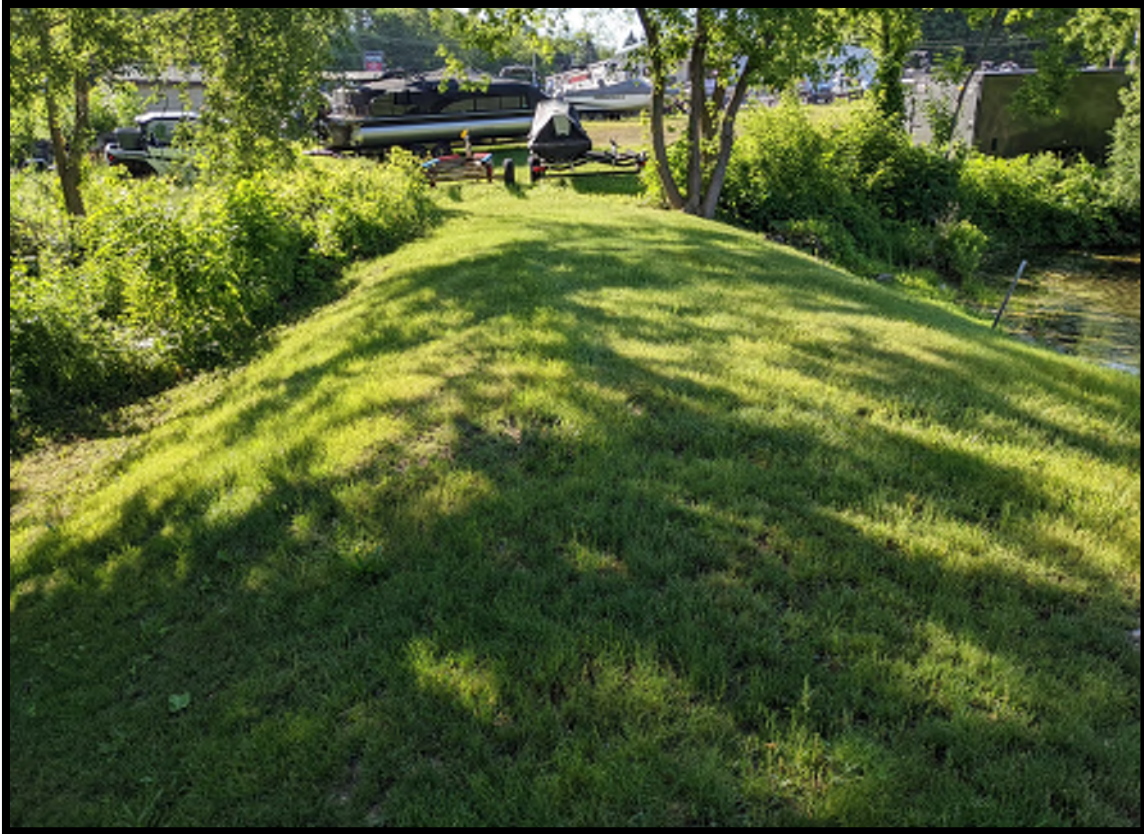
**East (left) embankment looking southeast
0021006162207.jpg**

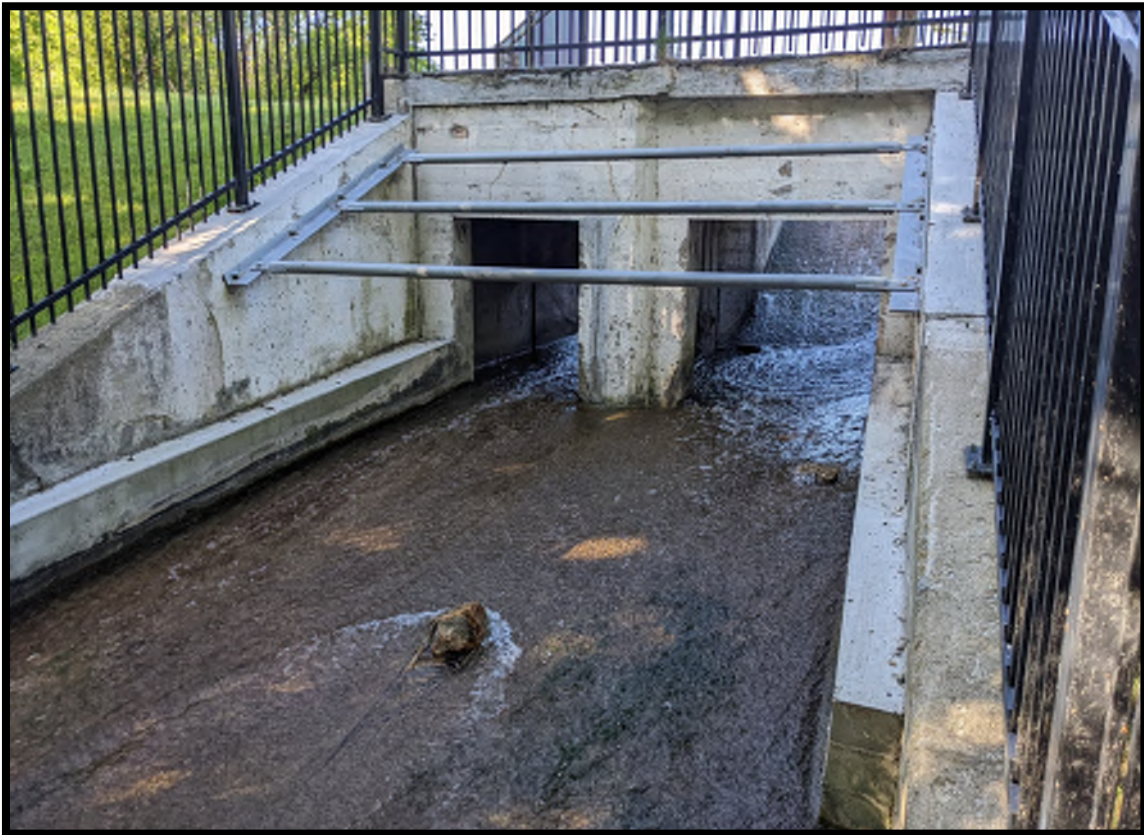
Since the last inspection, the powerhouse has been removed.

**Downstream view of dam (former location of powerhouse)
0021006162208.jpg**

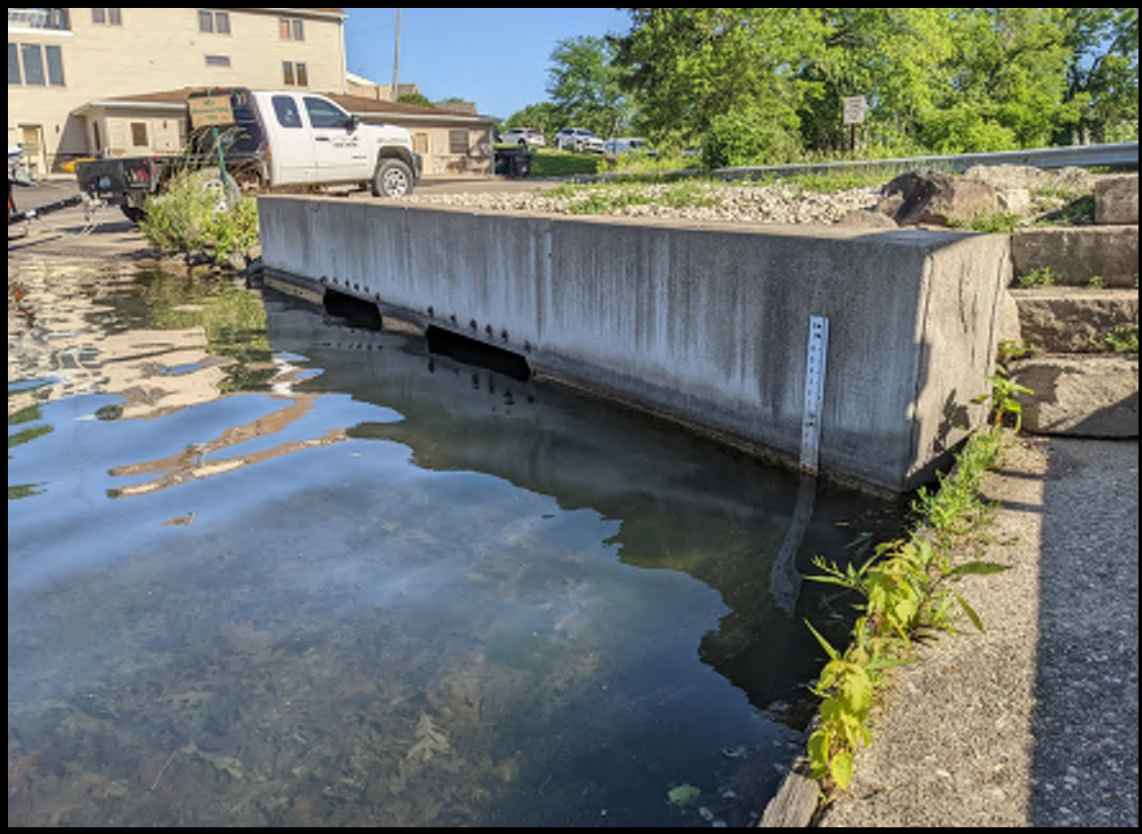
Upstream headwall and culverts
0021006162209.jpg

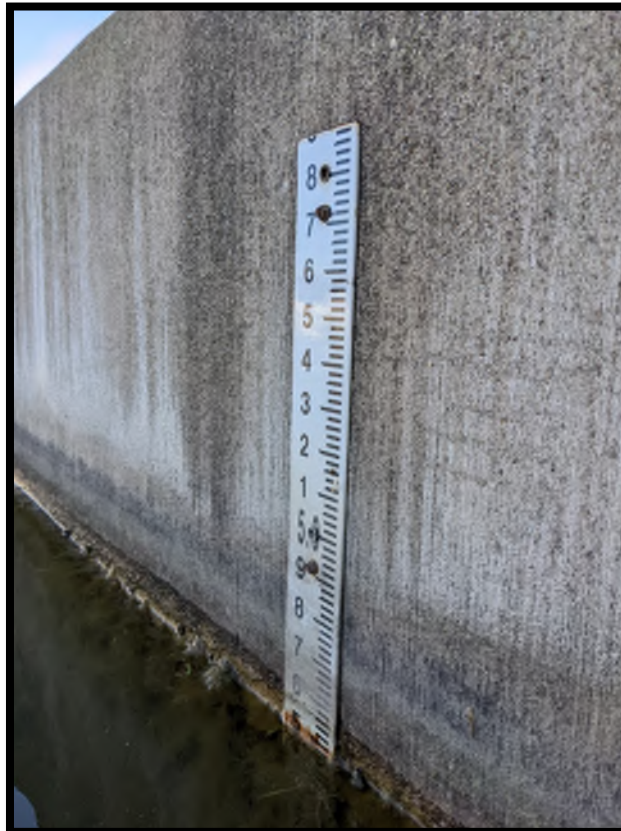
Gauge on upstream culvert headwall
0021006162210.jpg

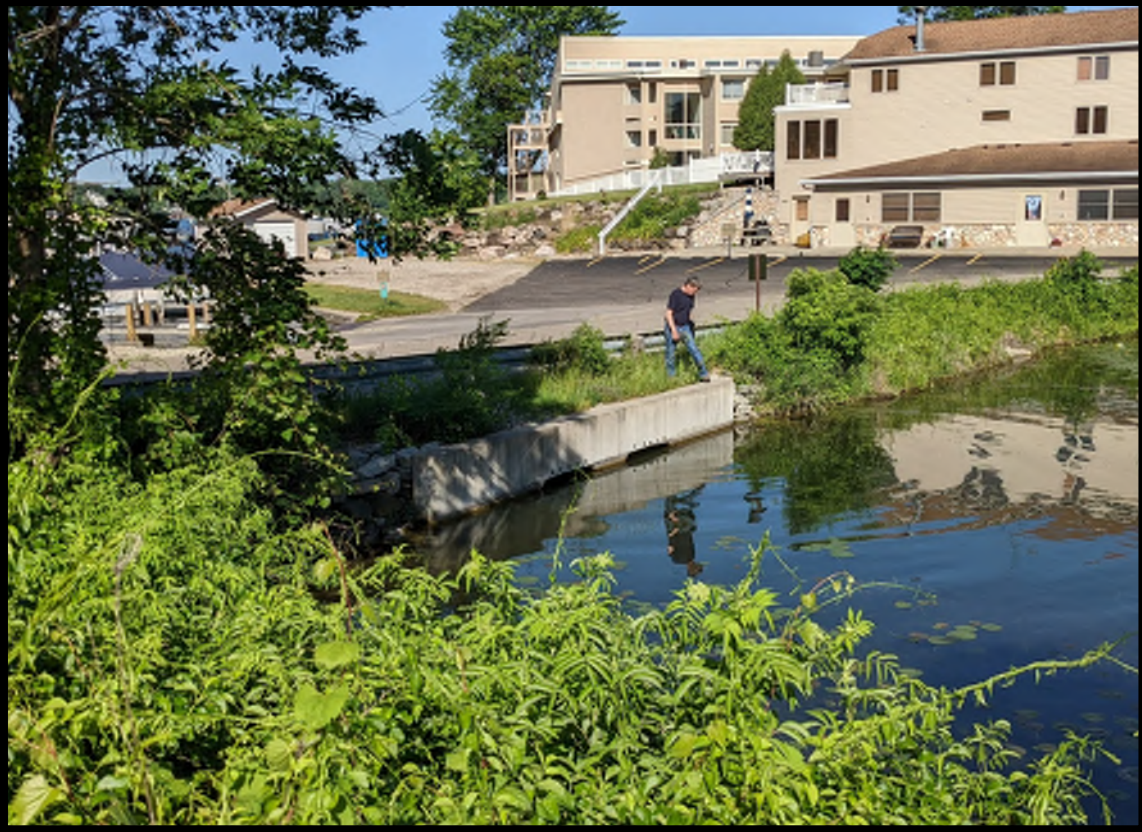
Downstream headwall and culverts
0021006162211.jpg

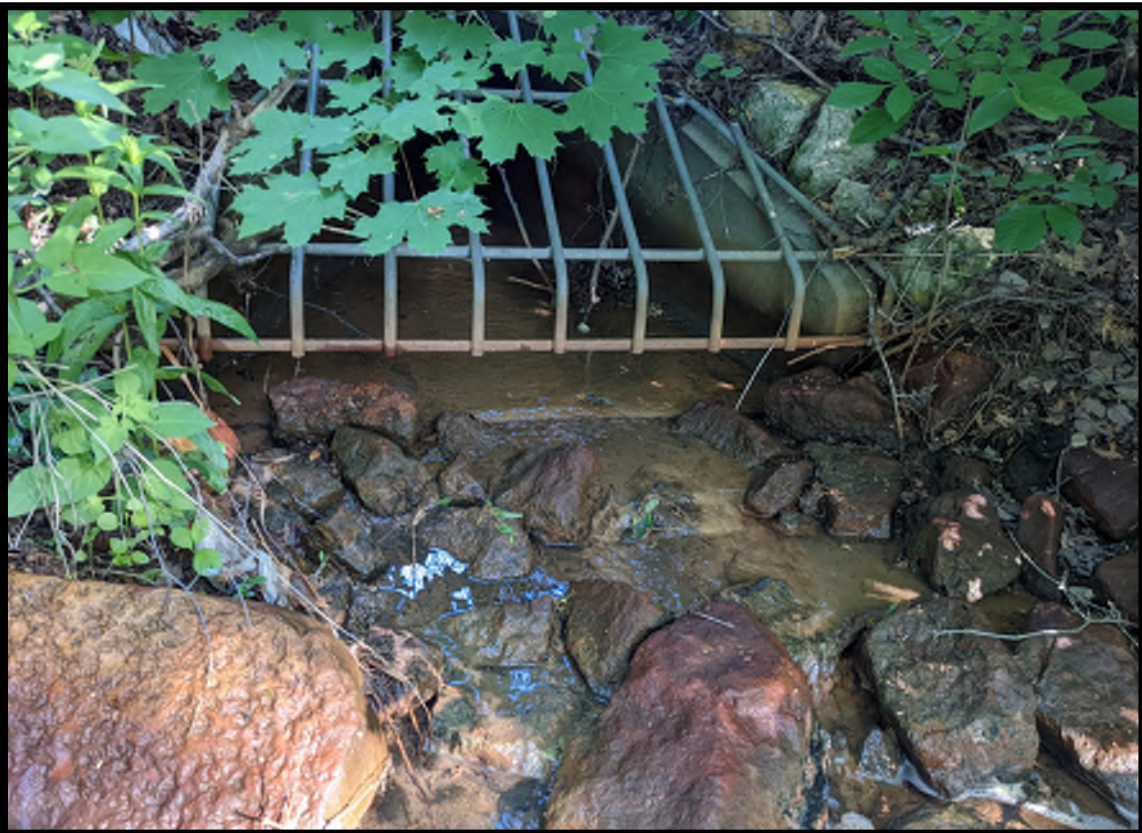
Outfall sewer pipe from Sterlingworth Bay
0021006162212.jpg

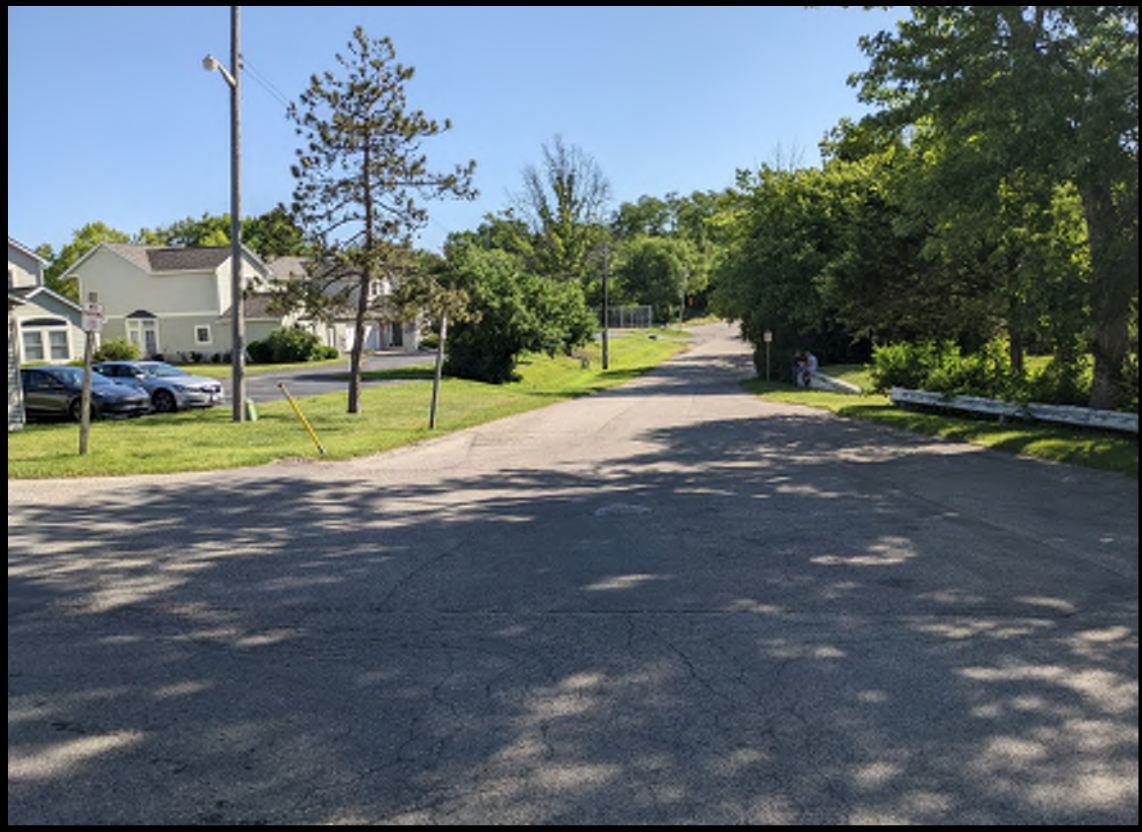
**Roadway portion of Sterlingworth Bay embankment
0021006162213.jpg**

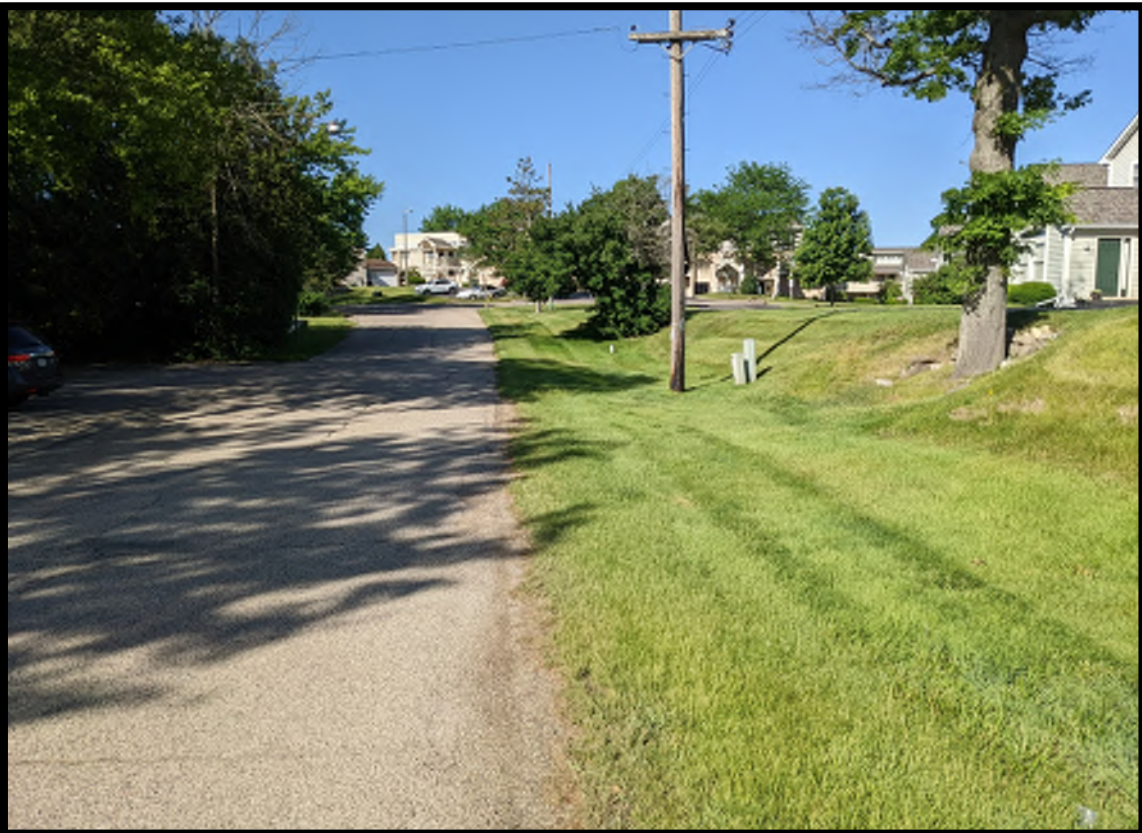
**Sloped grass embankment of Sterlingworth Bay (roadside)
0021006162214.jpg**

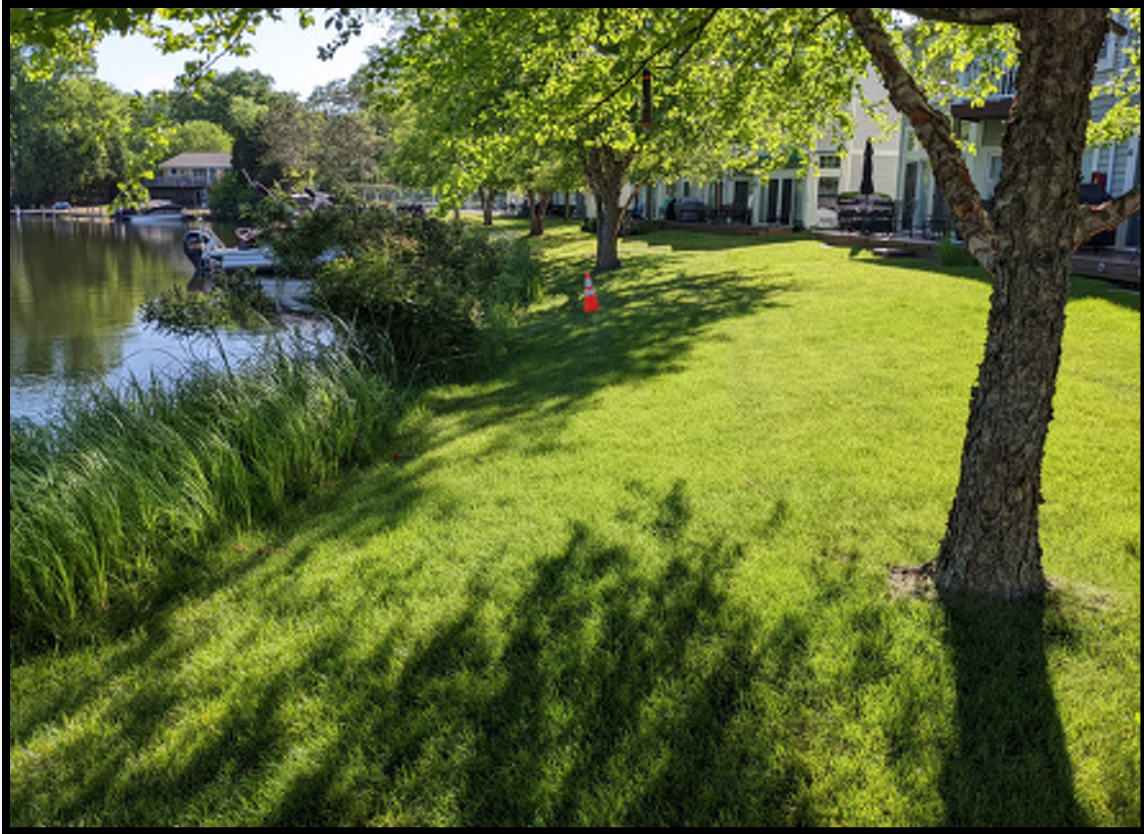
**Sterlingworth Bay south embankment
0021006162215.jpg**

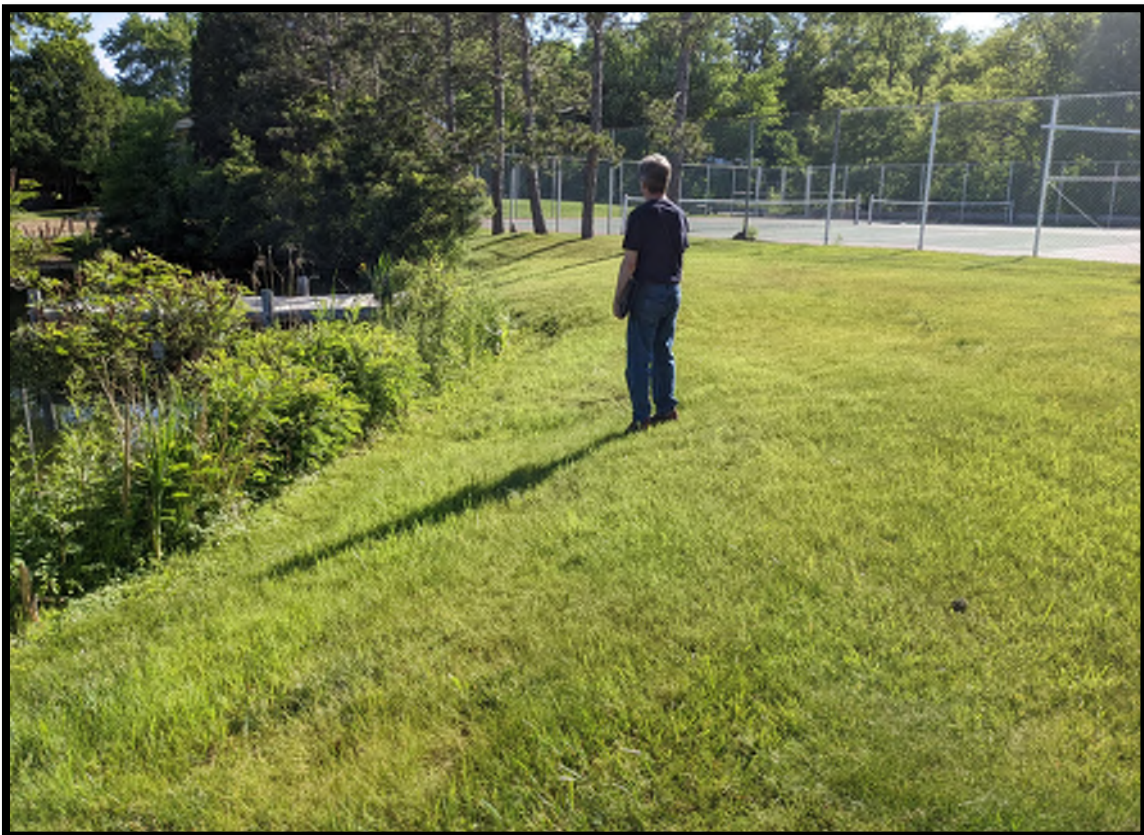
1. Dam structures are in good condition overall
2. Sparse grass cover was found along west embankment of primary dam. It is recommended to seed and fertilize the area to establish denser vegetative cover.
3. Sterlingworth Bay embankment and shoreline appear to be stabilized with natives growing around the previously placed stone.
4. No erosion problems were evident near either dam.
5. No evidence of seepage problems was observed at either dam.
6. The mill building has been removed since the last dam inspection. There is no longer a high risk of debris build up that would obstruct flow.

**Stabilization measures on Sterlingworth Bay (natives over riprap)
0021006162216.jpg**
